Water Detection Sensor BAF147

Thermometrics Water Detection Sensor BAF147 detects moisture leakage via a change in resistance value of the sensor and feeds a signal to the Battery Management System (BMS) to warn the driver.

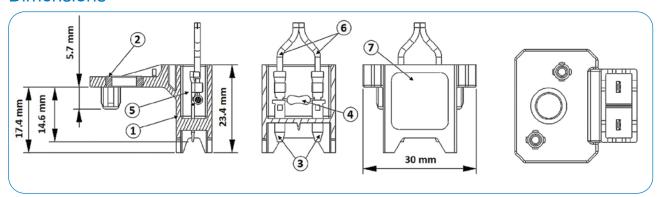
Dimensions

No.	Construction List	Material	Notes
1	Case	PBT	Black
2	Bush	C3604	
3	Terminal	C2680-1/2H	Pre-Tin, Cu/Sn
4	Resistor	510 kΩ	1/4 W
5	Resin	Ероху	Black
6	Wire	AVSST, 0.3SQ	Black/Black
7	Label	15 X 15 mm	Laminated Coating
